# Field Trip 4

## Urban Ground Fissures and Loess Landslides

### Xi'an Ground Fissures - City Wall Pathological Conditions

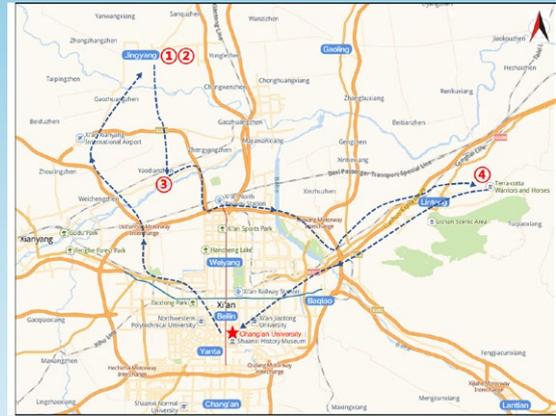
- ① Yu Huazhai Ground Fissure;
- ② Liangshan Park Ground Fissure F12 Monitoring Station;
- ③ Xiying Road Ground Fissure F7 3D Automatic Monitoring Station;
- ④ Xi'an City Wall Pathological Conditions

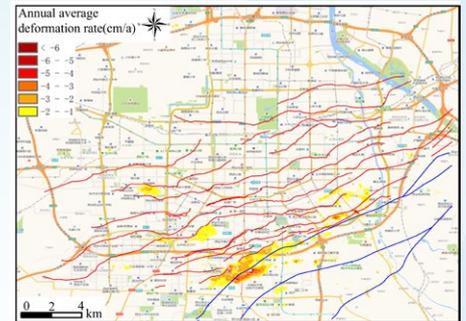
Distribution of Ground Fissures and Ground Subsidence in Xi'an

The field trip team will visit typical ground fissures and their monitoring stations in the urban area of Xi'an, as well as the pathological conditions of the Xi'an City Wall and its monitoring stations. There are a total of 12 ground fissures in the urban area of Xi'an (as shown in the diagram below), with a trend of northeast to east and a dip angle ranging from 70° to 85°. Through a day of visits, we will gain an understanding of the significant adverse impacts caused by the activation of urban ground fissures on ground stability and engineering structures.

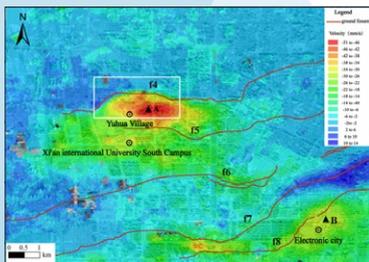
Annual average subsidence rates in the Yu Huazhai area from 2018 to 2020

InSAR monitoring results, from 2013 to 2016, the maximum vertical displacement of the F4 ground fissure increased from 300 mm to 650 mm. The maximum annual vertical activity rate reached 87.5 mm/year (as shown in the diagram below), causing severe deformation and damage to roads and buildings, and affecting the normal operation of Xi'an Metro Line 3 (as shown in the diagram below).

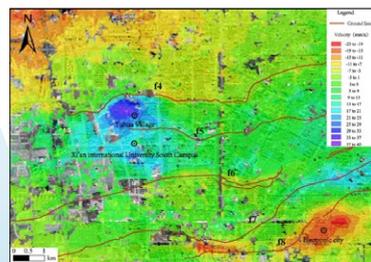
Xi'an F4 Ground Fissure and Nearby Ground Subsidence Rates (2015-2020)

After November 2018, the groundwater level rose by nearly 30 meters in a span of 5 months, almost synchronously with the ground rebound (as shown in the diagram below). From the water level monitoring profile of the F4 ground fissure, it can be observed that the relative deformation on both sides of the fissure decreased as the groundwater level rose after

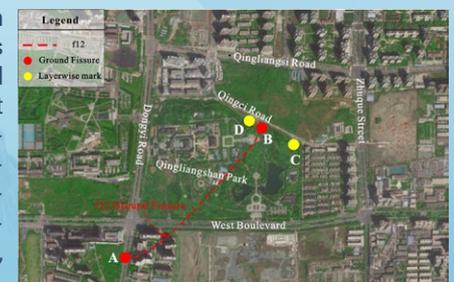
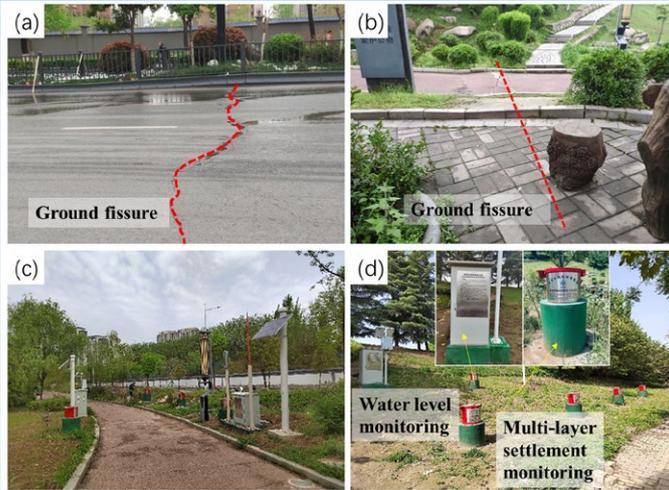
↑ The F12 ground fissure and layer markers (positions A, B, C, D as shown in the diagram above)

The F12 monitoring station for the ground fissure at Qingliangshan Park is located on the north side of Qingliangshan Park in Chang'an District, Xi'an (as shown in the diagram below). It was funded by the Xi'an Municipal Bureau of Natural Resources and Planning, with design and construction carried out by Chang'an University. The horizontal leveling profile and layer target monitoring are implemented by the Shaanxi Xi'an Ground Fissure Ground Subsidence Field Scientific Observation Station of the Ministry of Natural Resources. By monitoring the ground subsidence of the ground fissure zone and its upper and lower blocks, the compression between different depth soil layers, and the dynamic changes in groundwater level, scientific data can be provided for the current activity status, affected areas determination, causative mechanism analysis, and disaster prevention and control of ground fissure ground subsidence.

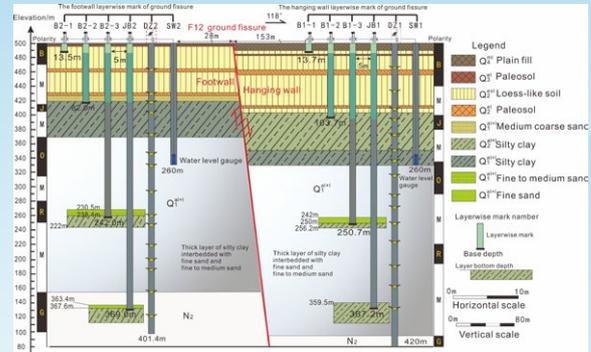
↑ Layer Markers for Ground Fissure Monitoring at Qingliangshan Park

The ground subsidence monitoring station for the ground fissure is located on the north side of Qingliangshan Park. The leveling monitoring profile spans the construction of the F12 ground fissure and includes 6 benchmark points and 2 sets of ground subsidence layer markers. Each set of layer markers is located on both sides of the ground fissure and consists of 4 single-point layer markers, 1 water level monitoring hole, and a single-hole multi-layer monitoring hole.

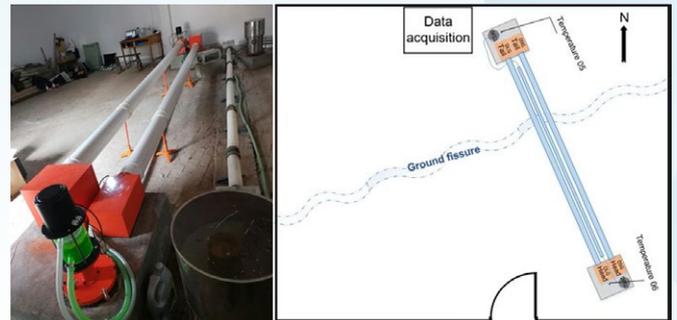
↑ Three-Dimensional Deformation Monitoring System for Fault Zones

The Xi'an ground fissure three-dimensional automated monitoring station is located at Xi'an Engineering Technology School on Xiying Road. The design and construction unit is the Shaanxi Geological Environmental Monitoring General Station, and the GNSS monitoring is undertaken by Chang'an University. Through three-dimensional automated monitoring, the horizontal torsion, horizontal strain, and vertical relative subsidence between the upper and lower blocks of the ground fissure are observed separately. In addition, a set of horizontal monitoring points for ground fissure, a set of ground subsidence layer monitoring stations, and a set of GNSS monitoring stations are set up outdoors at the automated monitoring station.

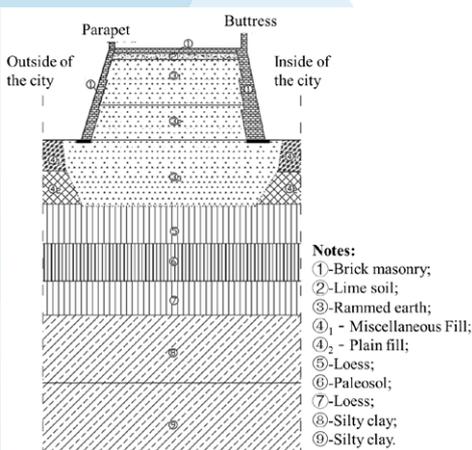
↑ Profile Schematic of the Wall Structure in the Yongning Gate Area of the Xi'an City Wall

The Xi'an City Wall is constructed using an external brick and internal soil structure. During its construction, a wider trench was first excavated, and then the soil layers were compacted in layers within the trench. Below the compacted soil layers are the original accumulated loess, ancient soil, and clayey silt (as shown in the diagram below).

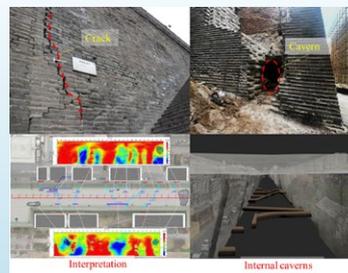
↑ Xi'an City Wall Damage and Geophysical Exploration

Due to its age, climate, groundwater, and the combined impact of engineering activities, the Xi'an City Wall has experienced localized cracking, subsidence, and other damages. In response, the Mechanical Industry Survey and Design Research Institute Co., Ltd. has been involved in the monitoring of the city wall since the 1990s. Through the use of conventional instruments, Internet of Things (IoT) monitoring, geophysical exploration, and other methods, comprehensive monitoring covering a total length of 13.74 kilometers of the Xi'an City Wall has been implemented (as shown in the diagram below). The monitoring includes wall deformation, groundwater, vibrations, voids, and other aspects. Based on specialized research, four-color warning thresholds for deformation monitoring of the Xi'an City Wall have been determined, and a four-color warning monitoring system has been established, laying the foundation for proactive protection of the Xi'an City Wall.

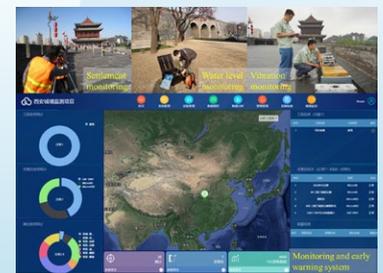
↑ Monitoring and Early Warning System for Xi'an City Wall Damage

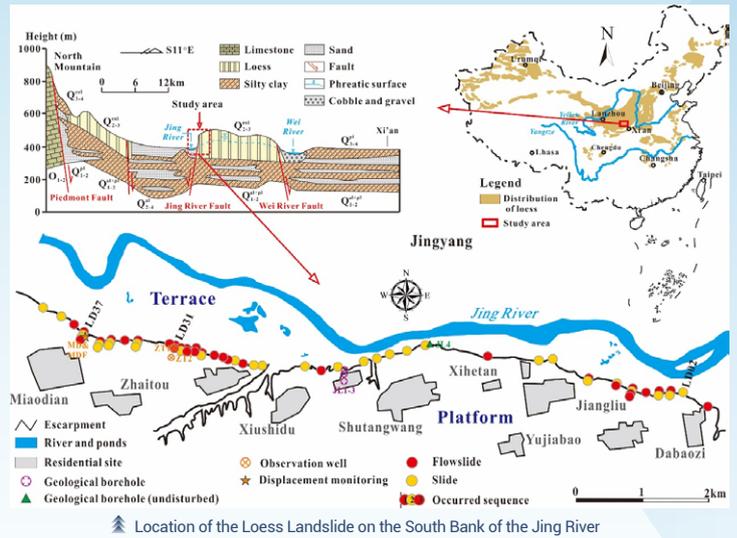
Location of the Loess Landslide on the South Bank of the Jing River

The loess terrace on the south bank of the Jing River in Shaanxi Province is one of the most representative areas prone to landslides in the world. Since the beginning of agricultural irrigation in 1976, a total of 62 severe loess landslides have been recorded (as shown in the two figures below). These landslides have caused significant economic losses and casualties. Among these landslides, the Jiangliu landslide in 1984 buried a small village and resulted in 20 deaths. In the extremely dry climate of northwest China, irrigation is necessary to transform natural loess into farmland. However, long-term irrigation disrupts the natural water cycle of the Loess Plateau. With ongoing irrigation activities, the groundwater level in the slopes at the edge of the plateau gradually rises, reducing the stability of the slopes and eventually leading to these landslides.

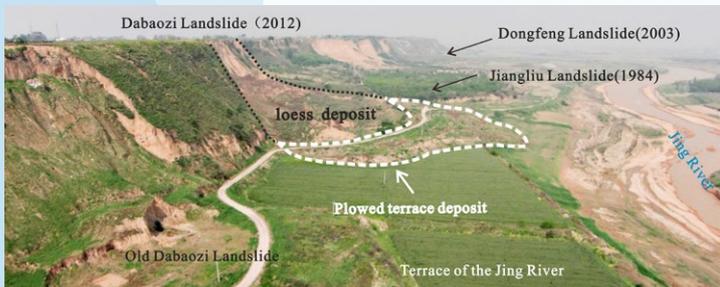
Aerial view of the landslide group on the south bank of the Jing River

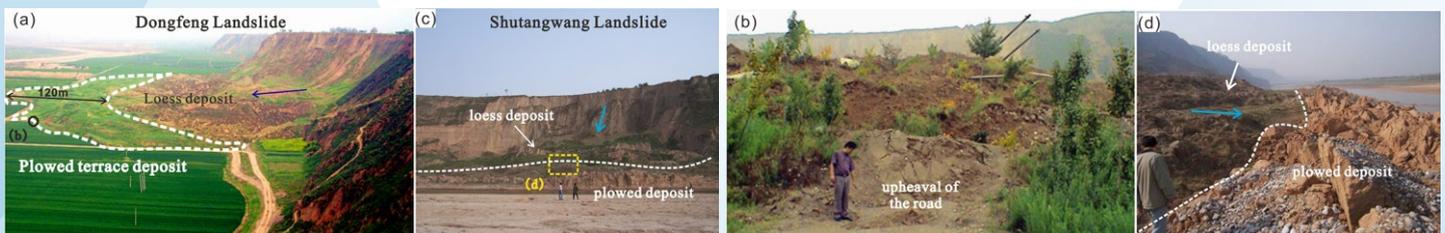
Entrainment phenomenon in loess landslides.

There are four typical loess landslides in this area: Dabaozi landslide, Jiangliu landslide, Dongfeng landslide, and Shutangwang landslide. They exhibit three notable characteristics: (1) they develop on steep loess slopes at the edge of the loess terrace; (2) they have a high kinematic energy and slide rapidly; (3) they violently impact the saturated sandy soil of the Jing River terrace, causing liquefaction and entrainment of the saturated sandy soil (as shown in the figure below).

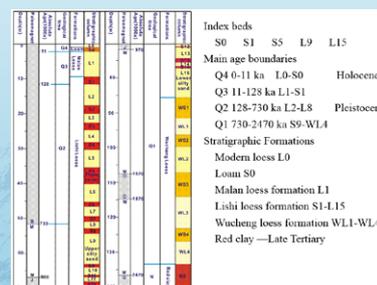
Typical Geological Profile of the Loess-Paleosol Sequence on the South Bank of the Jing River (Professor Liu Dongsheng)

The loess-paleosol sequence is a detailed record of the cold-dry and warm-wet cycles in the Loess Plateau of China over the past 2.5 million years. On the loess slopes on the south bank of the Jing River, there are several well-exposed layers of loess, revealing a continuous loess-paleosol sequence from the modern deposit of loess (L0) to the ancient paleosol (S0, 0-11,000 years) and then to the loess (L9) (as shown in the first figure below). During this field trip, you will visit a profile near the landslide site (as shown in the second figure below), which has a good correlation with the standard profile.

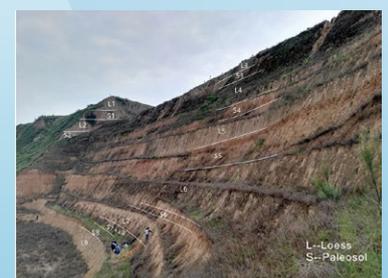
Loess-Paleosol Sequence on the North Side of the Xi'an Loess Plateau

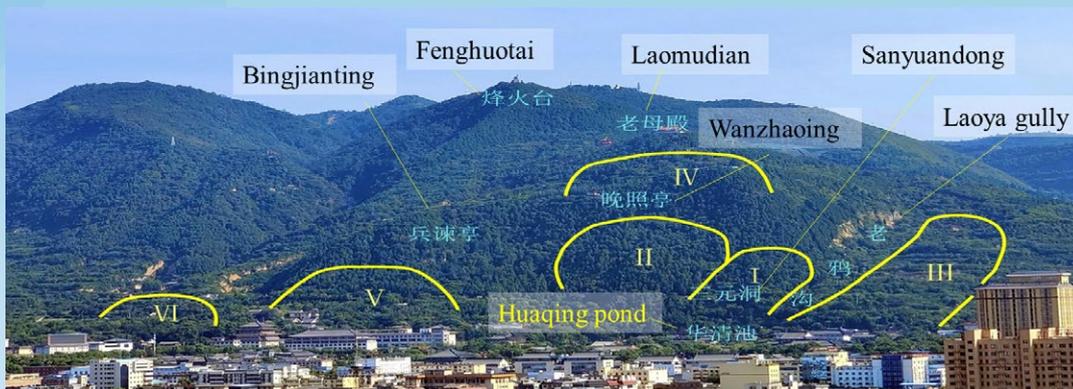
Lishan Landslide and its Zoning

The Lishan landslide is located on the northern slope of Lishan within the Huashan Palace scenic area. It stretches approximately 220m east of Donghuayuan and 150m west of Mudangou, reaching north to Huashan Pool and south to 50m north of Laomudian, covering an area of about 0.5km<sup>2</sup>. The Lishan landslide poses a direct threat to the safety of the Huashan Palace scenic area, the Railway Ministry Lintong Sanatorium, Lintong Lixing Cableway Co., Ltd., Huayuan Half-Mountain Hot Spring Hotel, and the eastern military camp area. Based on the landform morphology, deformation characteristics, and the potential harm to Huashan Pool, the landslide is divided into six zones: I, II, III, IV, V, and VI (as shown in the figure below).
